LAND CORNER RECORD

Index: T5	Corner: 1/4 corner between Section 29 & 30	State of Indiana - Hoosier National Forest		
Section: 29/30	Township: 7N	Range: 1E	P.M.: 2nd	County: Monroe
Coordinate:	Lat./N: +/-1371719.7	SEE NOTE BELOW	Lon./E: +/-3134842.7	SEE NOTE BELOW
			Datum:	NAD83(sft)

MONUMENT RECORD
State of Indiana - County of Monroe

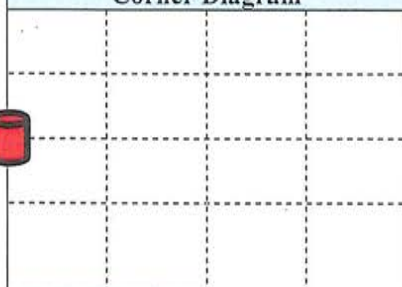
2012. 10. 10

View to the northwest

Corner Diagram		Accessories: Describe BTs & witness objects established to perpetuate existing evidence.					
		Bearing Trees repainted and tagged:					
		S. Oak		Maple		B. Oak	
		12"		12"		24"	
		S 63°W		N 55°W		N 06°W	
		22.5 Ft.		19.6 Ft.		32.3 Ft.	
Corner Recordation:				Certificate Prepared:			
Filed and Recorded in				Date:			
County records:							
Book:				Page:			
Section:		29		Indiana State Plane Coordinates:		N. 1371719.624 E. 3134842.431	
				Edited By: Robert J. Stone		Date Created: 10/19/2012
